## Response of the Saver Dipole Beam Tube to Single Phase Helium Pressure

George Biallas and David Barner

January 19, 1983

One Energy Saver Dipole Beam Tube (#MB 124211) was tested under static and pulsed pressure conditions. Under static pressure, permanent deformation started at about 125 psi and reached .006 inches across flats after 220 psi exposure. Final catastrophic collapse occurred at 325 psi. Pressure pulses of shape and duration approximating the single phase helium pressure during a full house quench had no effect on the tube (previously statically pressurized to 220 psi) up to 285 psi and a slight yield effect at 305 psi. Repeated pulses at 305 psi appeared to cause little or no further yielding. When compared to static pressure effects the 305 psi pulse produced the same deflection as about 235 psi static pressure.

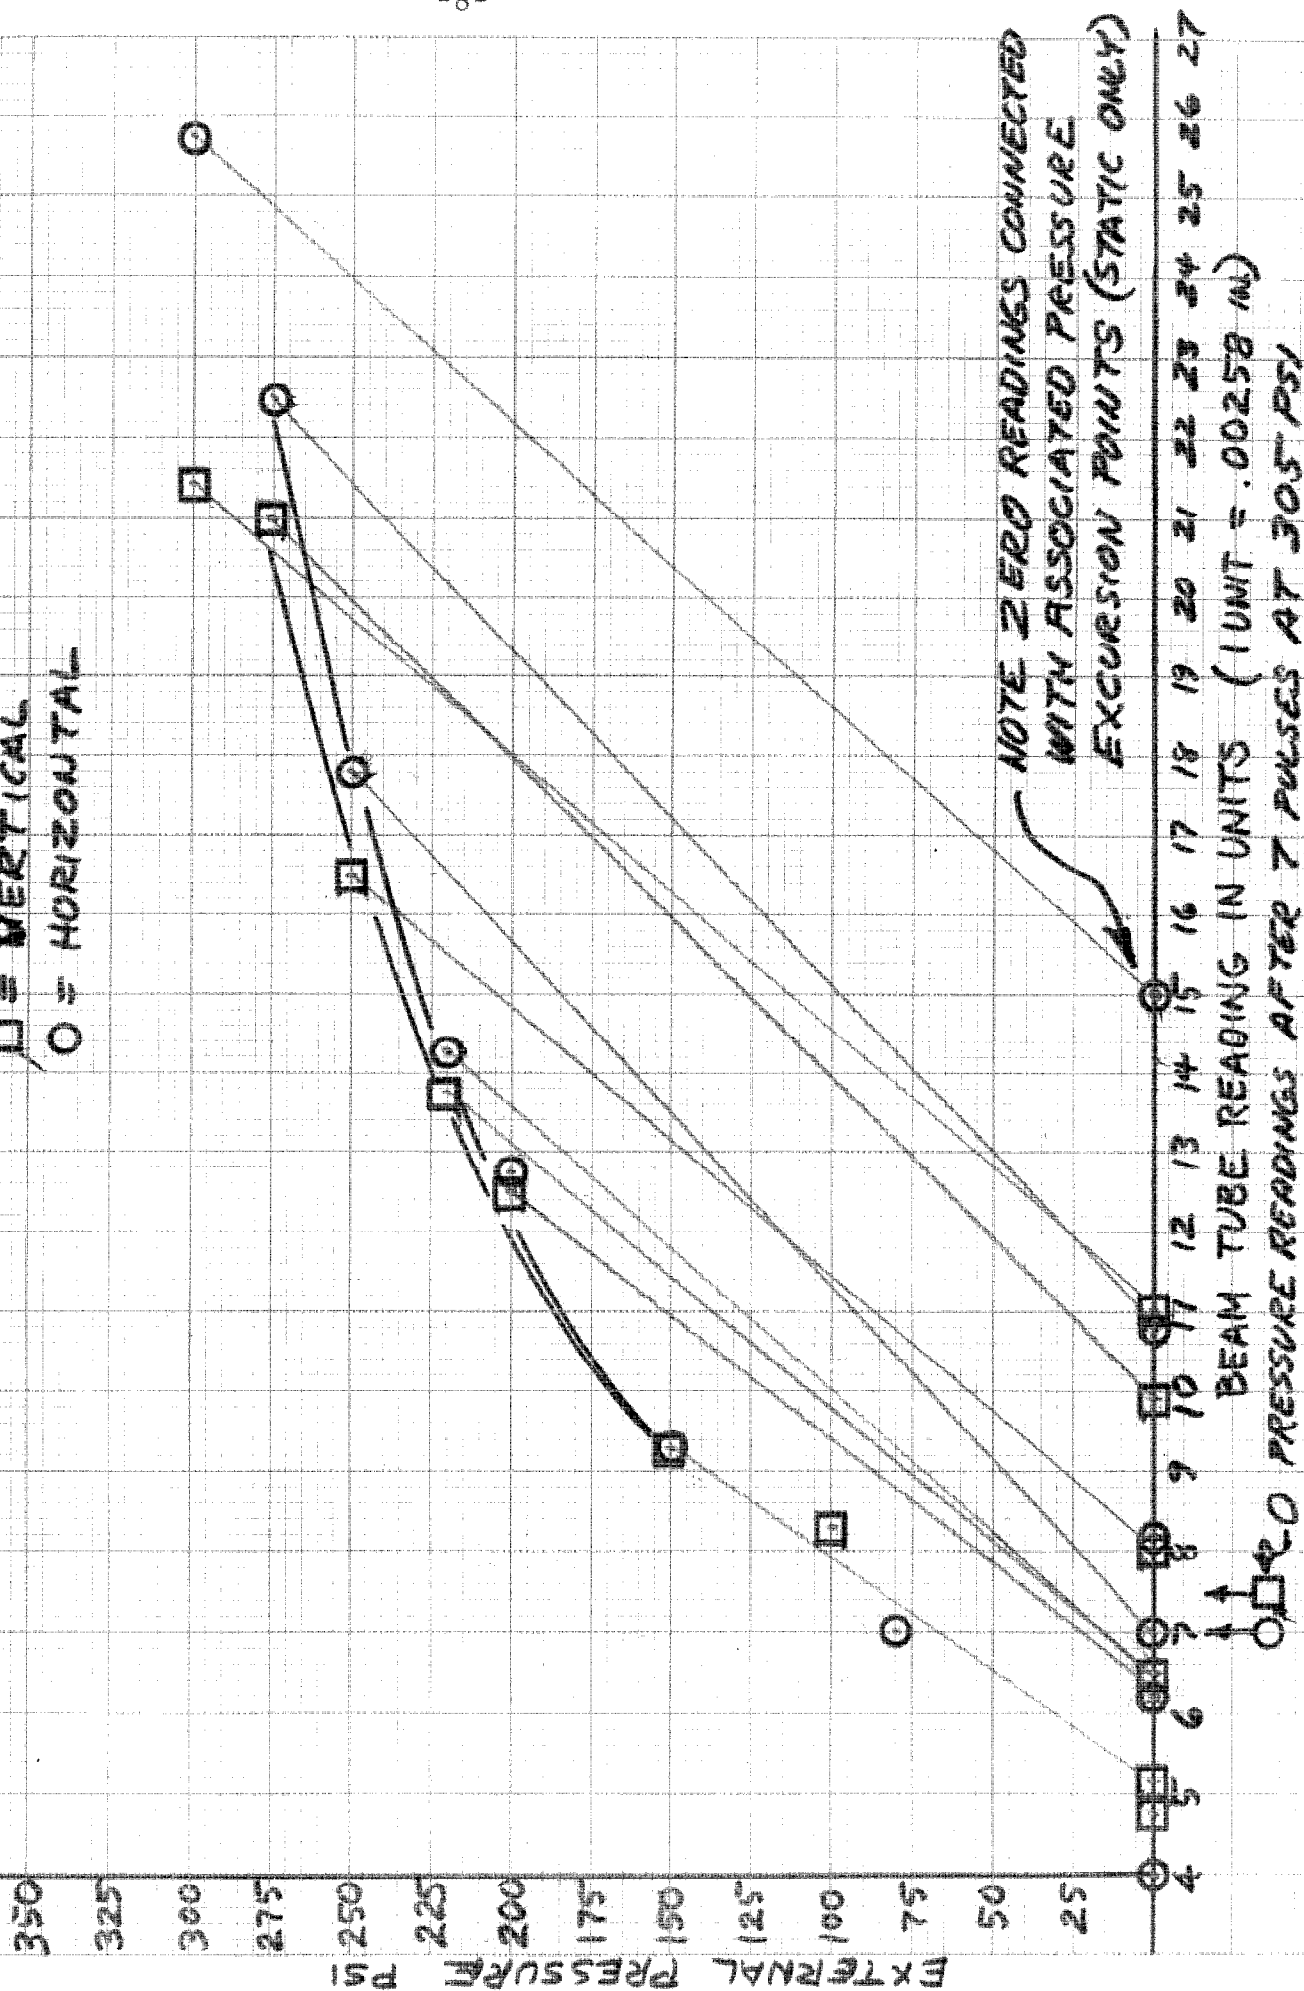
# GRAPH #1 BORE TUBE DIMENSION READINGS

FOR POINT OF COLLAPSE

□ = VERTICAL

○ = HORIZONTAL

↑ ZERO PRESSURE READINGS AFTER 7 PULSES AT 305 PSI

Some useful information may be obtained from plotting a force vs. deflection curve with readings taken where the final collapse initiated. This is shown in Graph 1. The curve shows that some permanent set starts at 125 psi or so with 220 psi static pressure creating about 2.5 units or .0065 total permanent set in the horizontal as well as vertical. I suspect a pulse at 200 psi would produce a smaller deformation if any at all.

Note that collapse occurred opposite to the seam weld. Graph 1 also has some additional information contained in it. I explain the reverse slope of the vertical curve at low pressures as the settling out of the square tube

to a diamond configuration, touching two corners against the coil I.D. The anomalous vertical point at 300 psi is a result of the severe inward deflection in the sides of the tube bending the top and bottom almost back out. Intermediate levels of pressure produce remarkably smooth curves for both horizontal and vertical readings.

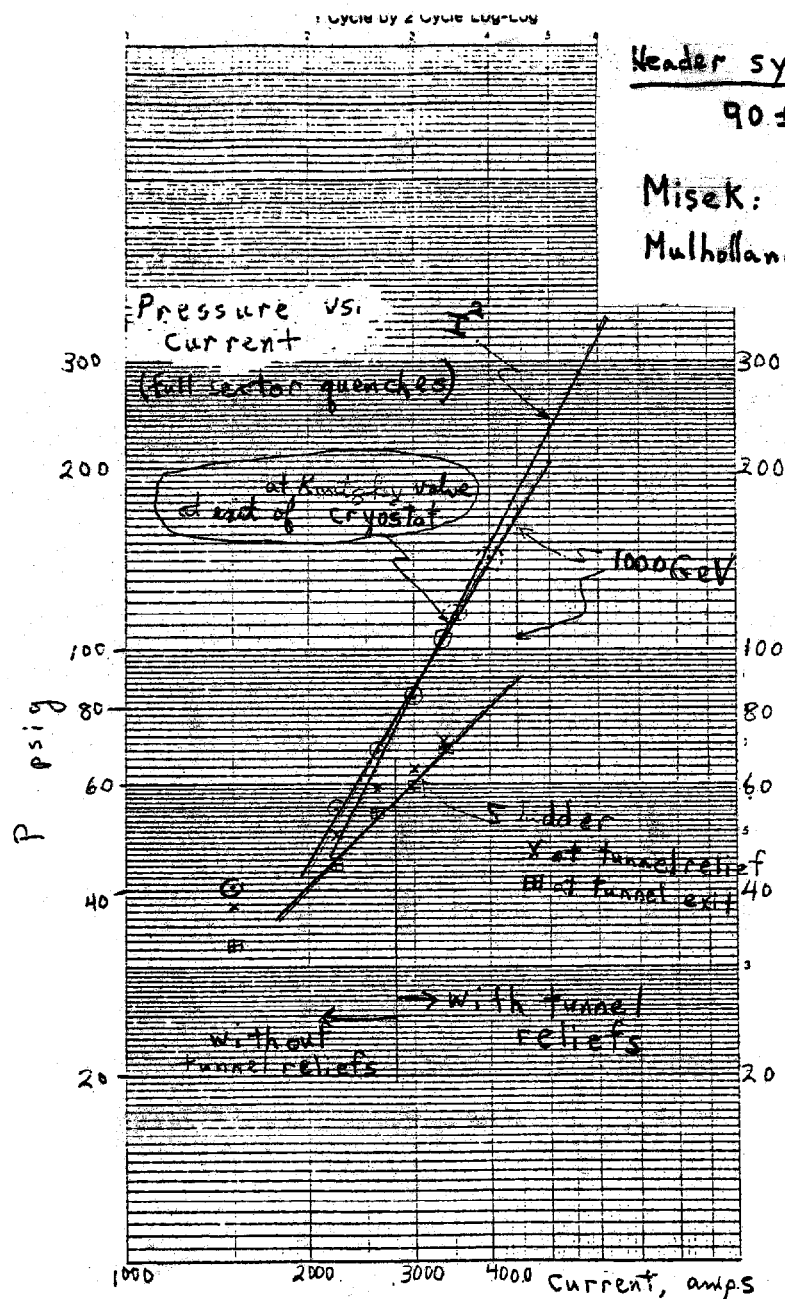
FIGURE 1

# Pressure extrapolations to 4440 A

## Cryostat:

$I^2$  extrapolation  
 168 - 185 psig at relief valve  
 eyeball fit of straight line to the data  
 198 - 215 psia in cryostat +15 for  $\Delta f$   
 +15 to absolute  
 228 - 245 psia if 1 relief valve fails (+30)

Biallis: cryostat OK to 275 psia  
 (bore tube collapse)

## Header system:

90  $\pm$  5 psig

Misek: header safe to 105 psig

Mulholland: rating = 100 psig

Thornton Murphy speculates that during a full house quench, with one Kautzky valve failed, the pressure rise may locally go to 240 psia in the single phase helium circuit of the Saver (see Figure 1). This was higher than previously thought and getting close to the estimated collapse pressure of the Saver Dipole Beam Tube. The following investigation was to determine the static pressure collapse pressure of the Tube and whether the pulse duration of a full house quench was short enough to be considered a

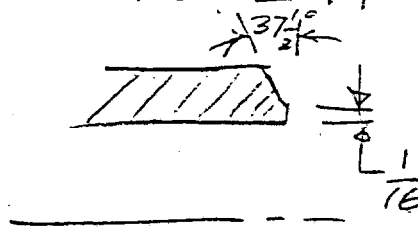
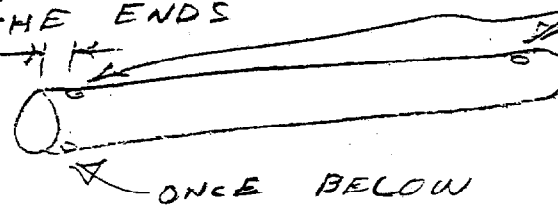
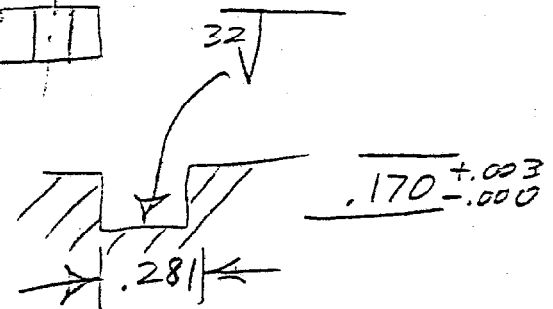
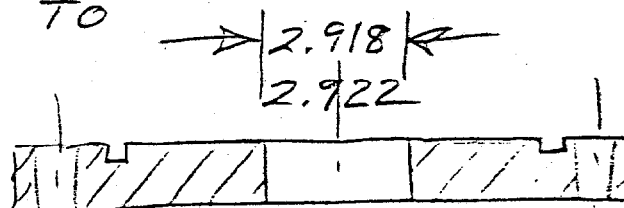
# FIGURE 2

## MODIFICATIONS TO PARTS

### FOR BEAM TUBE PRESSURE TEST

1. CUT 6" PIPE TO 24 1/2 INCHES; BEVEL EDGE FOR WELD PREP, BOTH ENDS

DRILL 1/2 DIA HOLE THREE PLACES  
3" FROM THE ENDS  
TWICE ON TOP  
ONCE BELOW

2. FACE OFF ALL FLANGES TO FLAT FACE.  
(BLIND FLANGES & WELD NECK)
3. MACHINE O-RING GROOVE IN BLIND FLANGES AS BELOW

4. SUPPLY 6 BARS 3/4 SQ X 11" LONG - STEEL
- 4A. WELD UP UNIT - SEE ADDITIONAL SHEET
5. AFTER PIPE PRESSURE TEST, BORE THE BLIND FLANGES TO

The apparatus consisted of three major parts. The first was the beam tube simulation. An insulated wrapped beam tube was placed inside a surplus, cut-off 22-foot coil. The coil and tube were placed inside a water filled vessel rated at 350 psi (see Figures 2, 3 and 4 and Picture 1). This duplicated service conditions. The second part (Figure 5 and Picture 2) was a borescope consisting of a lighted dial indicator which measured the tube across-flat dimensions. The dial indicator was read with a Brunson scope as the indicator was positioned at 6-inch intervals down the tube. The third part (Figure 6 and Picture 3) was the pressure pulse device consisting of a surplus hydraulic accumulator, pressure test gauge and valving system pressurized by a nitrogen cylinder. The pressure vs. time readout was acquired via a pressure transducer signal to a storage oscilloscope.

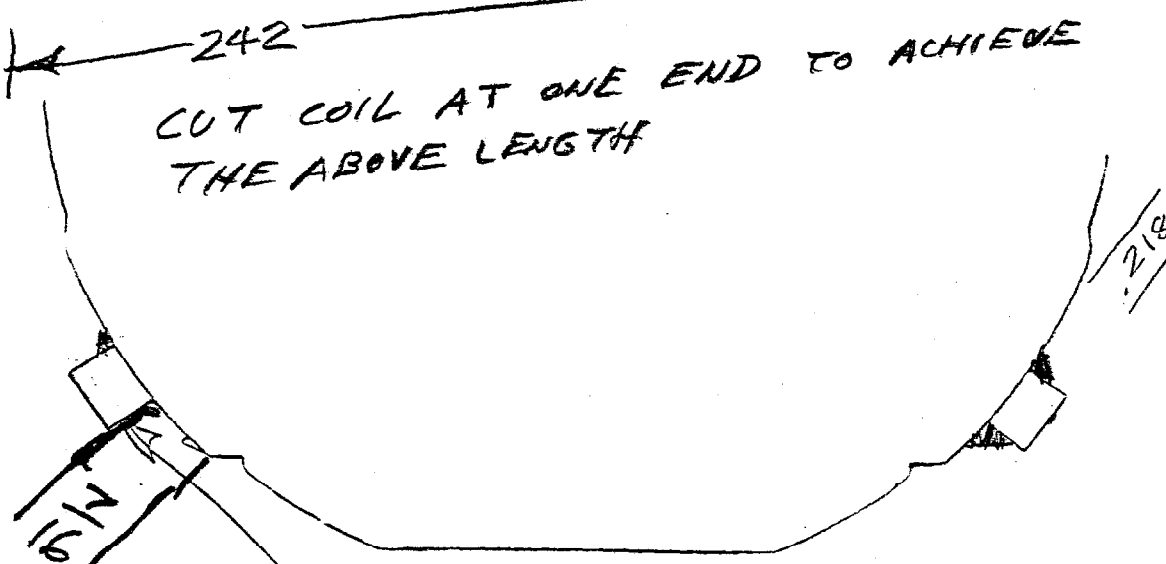
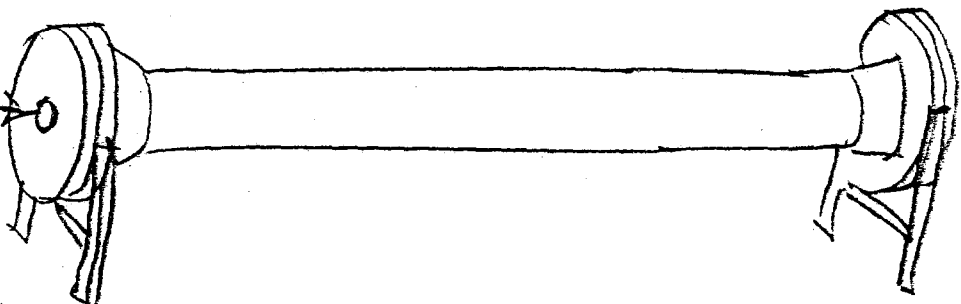
# FIGURE 4

## 22' COIL MODIFICATIONS FOR BEAM TUBE PRESSURE TEST

CUT COIL AT ONE END TO ACHIEVE  
THE ABOVE LENGTH
2.

TACK WELD SPACERS ON COIL BOTTOM  
AT 9 SUSPENSION LOCATIONS
3. INSERT COIL IN TANK AND MOUNT BEAM TUBE  
THROUGH COIL AND BLIND FLANGES.
4.

SEAL  
WELD  
BEAM TUBE  
TO FLANGE

USE 309 ROD

BOTH ENDS NO LEAK TEST REQUIRED.
5. SHIP TO PROTO MAIN FOR TEST

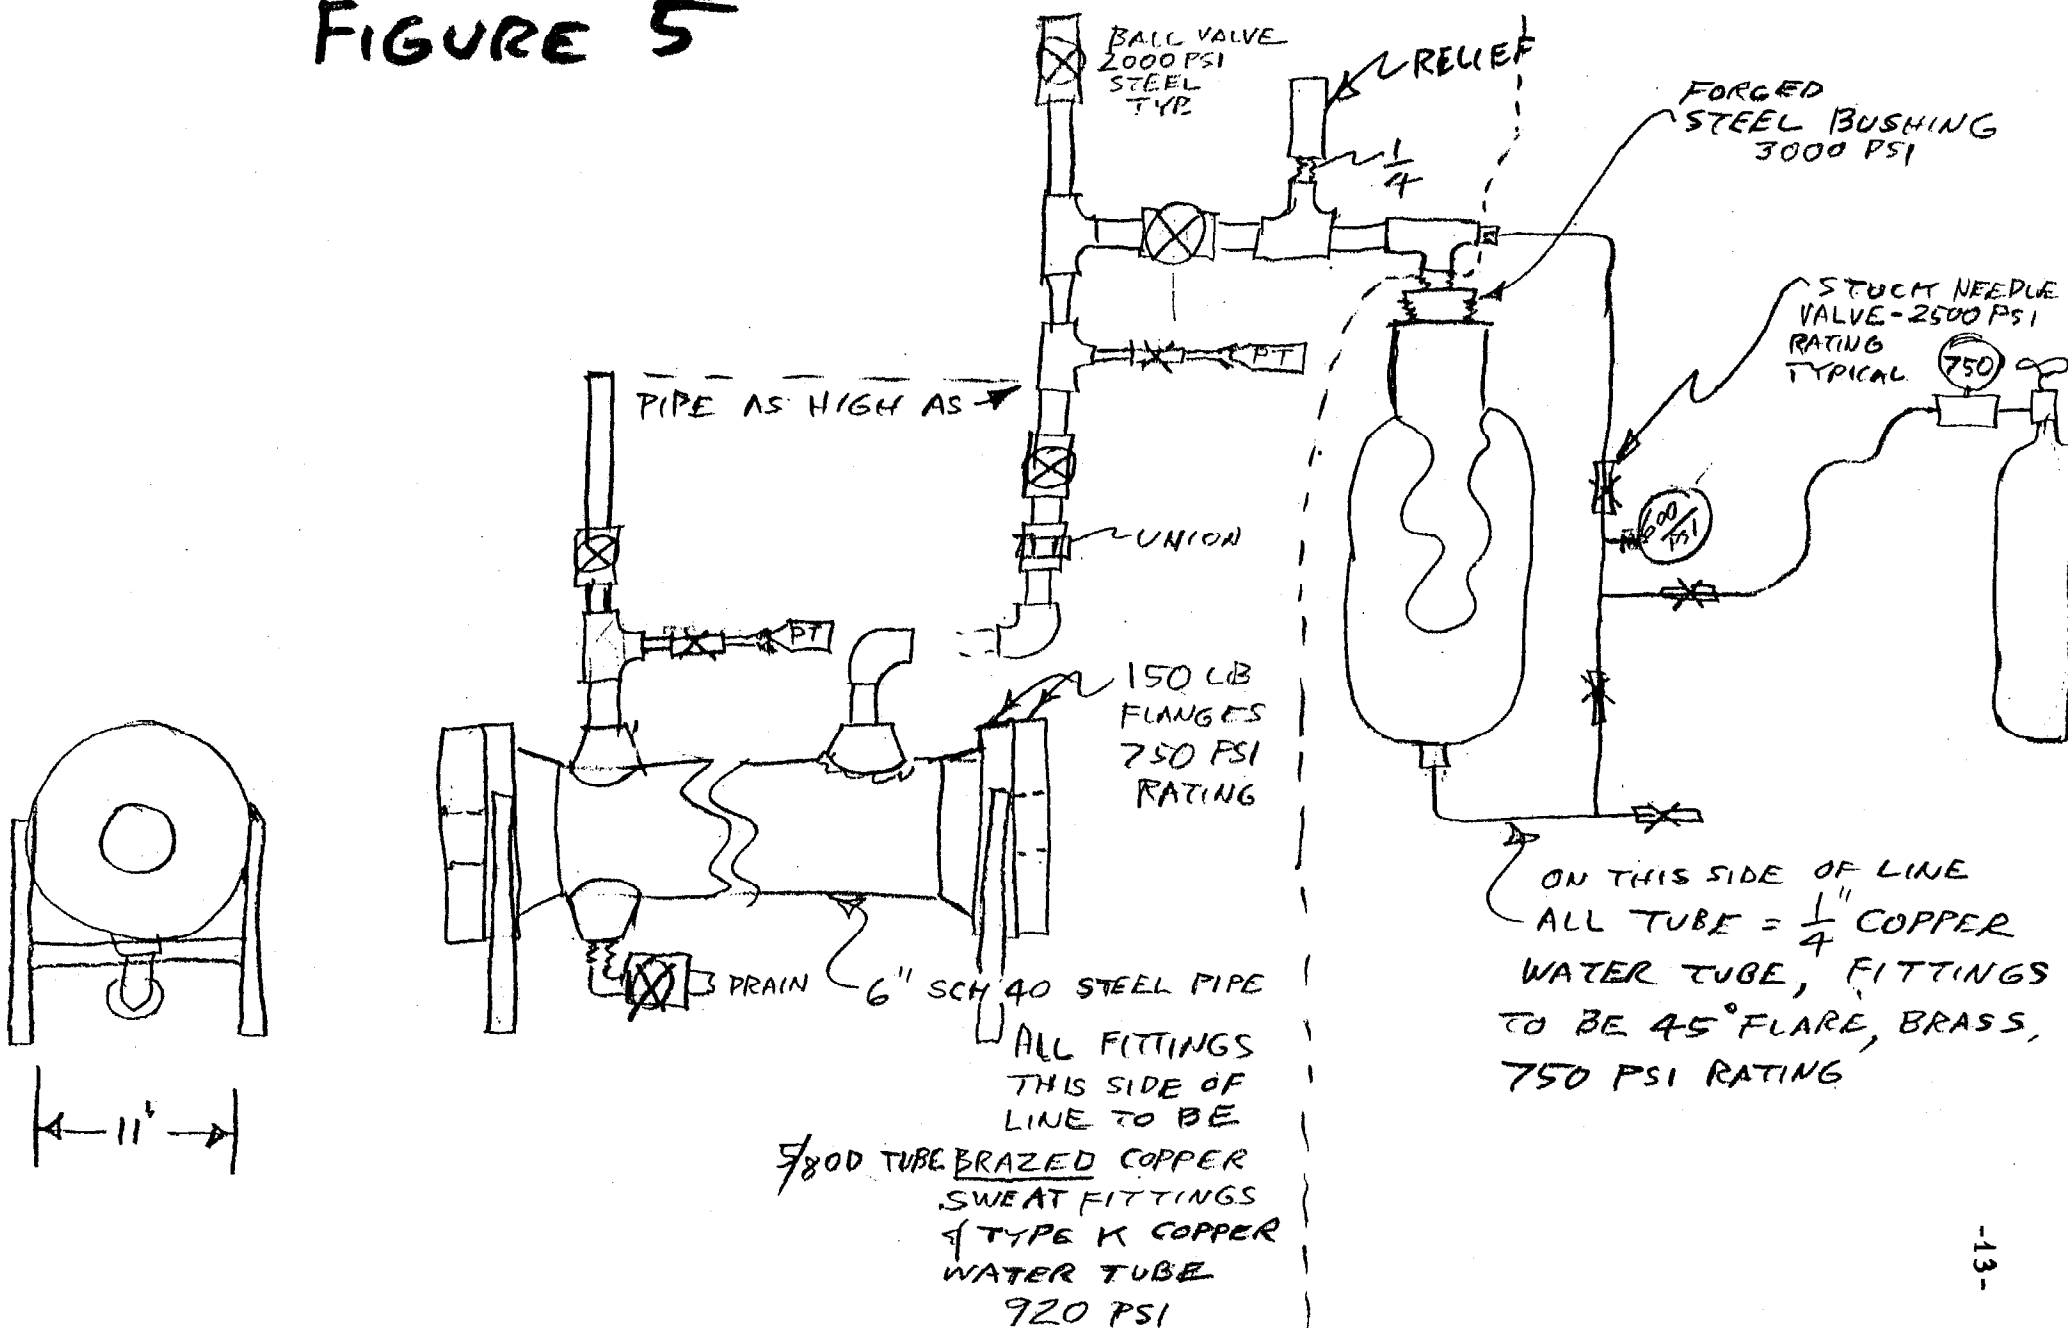
FIGURE 5

# CONFIGURATION OF BEAM TUBE PULSE PRESSURE TEST

750 PSI Maximum Pressure

The pressure pulser works as follows: a known quantity of gas in a bladder, backed up by a gas cushion, is discharged through a hand operated ball valve to a pipe system containing two branches. The lower branch contains the gas/water interface. The object to be tested is filled with water and the water is pressurized by the gas during activation. The upper branch of the pipe system contains a ball valve, venting to atmosphere, and settable to reproducible settings.

To produce a 305 psi pulse, for example, the bladder is vented to atmospheric pressure and the gas cushion side of the bladder is filled to 310 psi. Then the bladder is filled to 340 psi and thus has about 30/340 of the accumulator tank's gas volume. The ball valve is opened rapidly, pressurizing the pipe system in about 150 msec. The peak pressure is determined by the bladder's volume and the pressure. The setting of the vent valve as well as the original volume ratio of bladder to gas cushion determines the duration of the gas pulse at high pressure. At low bladder to cushion ratios, the gas cushion backup nearly maintains the fill pressure up to the time of the bladder's exhaustion. Subsequently, the pressure rapidly declines, simulating the rapid fall-off of the single phase pressure pulse.

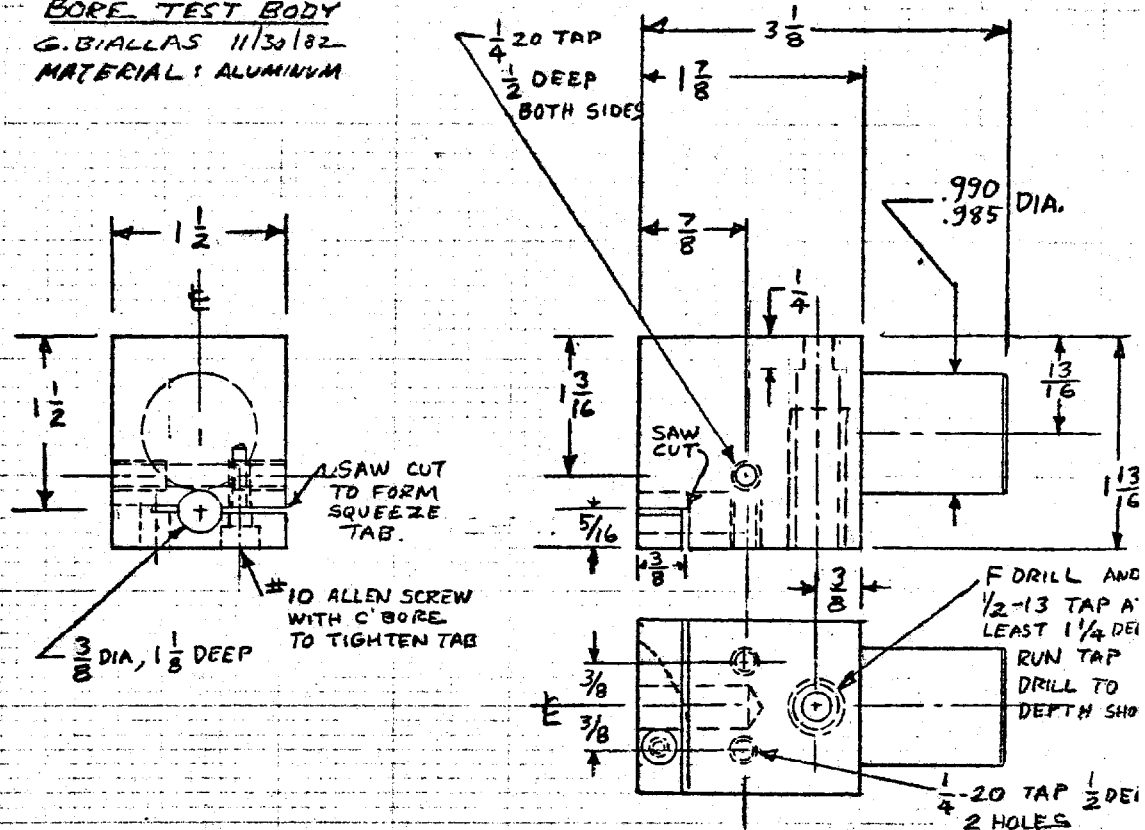
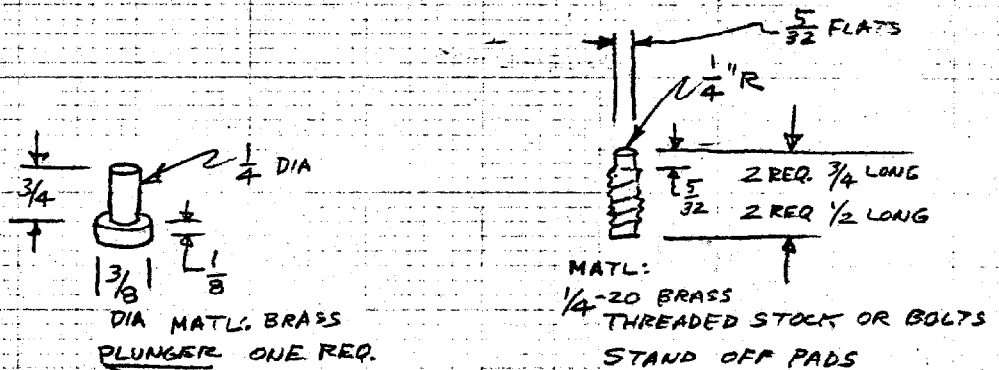
# FIGURE 6

BORE TEST BODY  
G. BIALLAS 11/30/82  
MATERIAL: ALUMINUM

JAM NUTS

MATL: STEEL OR BRASS  $\frac{1}{4}$ -20 TAP  
4 REQUIRED

Internal dimension was measured with a Brown and Sharp "finger" style dial indicator fitted with an extra long finger and mounted on a custom measurement probe. This finger changed the scale reading to 0.00258 inch per major scale division but correspondingly expanded the span of the instrument. Distance along the beam tube was repeated within  $\pm 1/8$  inch by positioning the probe via markings on the probe pipe. The dial indicator was "zeroed" by placing a short piece of beam tube over the measurement head. The zeroing was done before each reading set was taken to catch calibration error and compensate for wear in the probe feet.

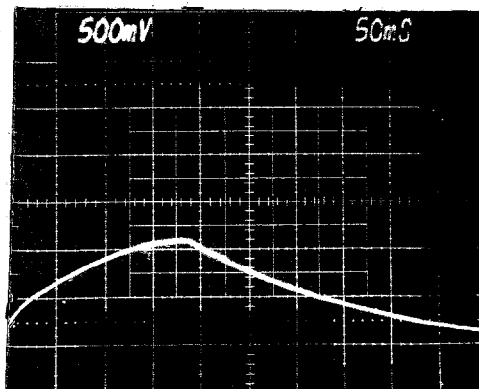
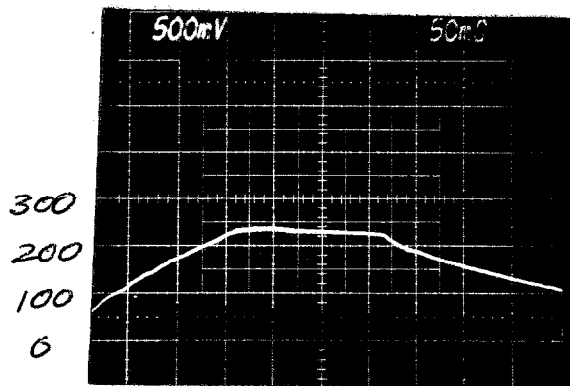
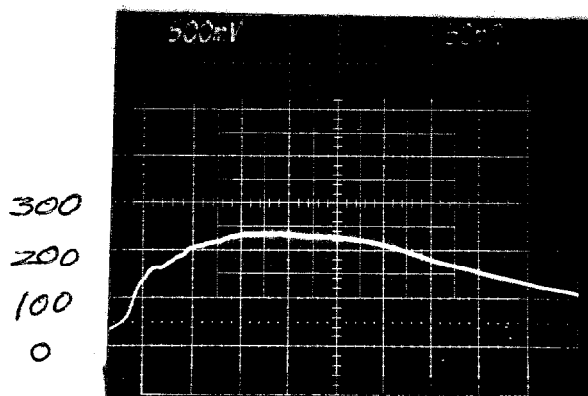
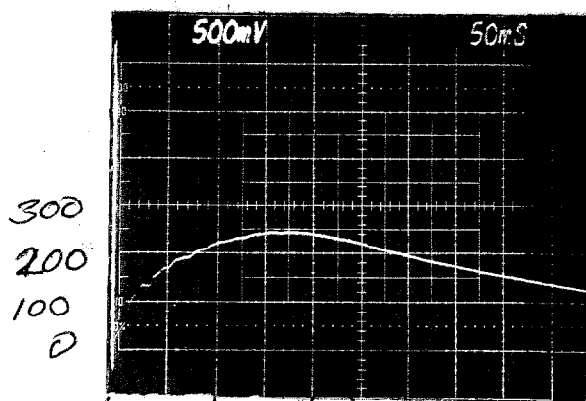
SHEET #1

PRESSURE PULSE RECORDS

PRESSURE - PSI

#1

220 PSI

#2

235 PSI

#3

#4

245 PSI

0 100 200 300 400  
TIME - m SEC

A second phase of testing consisted of pulse tests at 245, 285 and 305 psi (see picture pages). No permanent deformation was seen as a result of the first two pressure pulses and a 1/5 unit permanent set was noticed after the first 305 pressure pulse in the vertical and a half unit additional set was observed after 5 more attempts. In the horizontal, (the dimension in which the tube finally failed) a 3/4 unit deformation was observed on the first 305 psi pulse but no additional deformation occurred during the remaining attempts at 305 psi. By extrapolating from Graph 1, one conclusion to reach about the 305 psi pulse pressure is that it is equivalent to static pressure of, say, 237 psi. However there was anomalous behavior of the

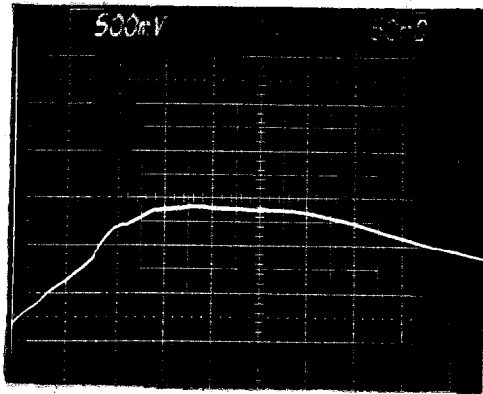
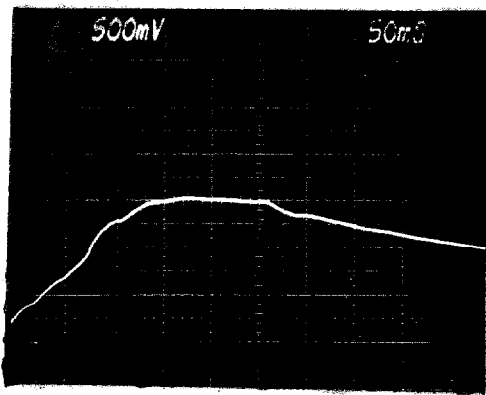
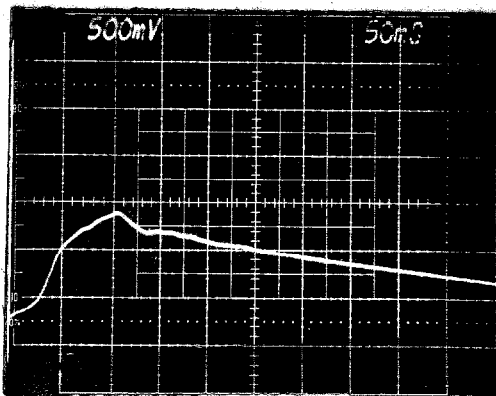
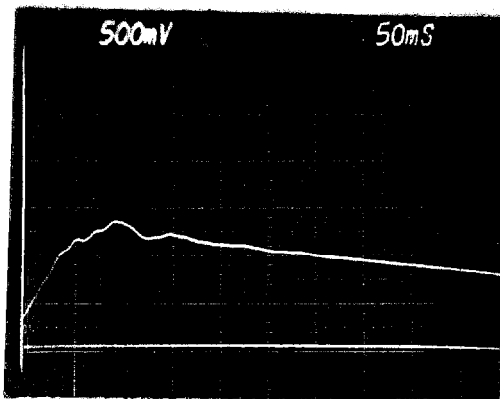
PRESSURE PULSE RECORDS SHEET # 2 -16-

PRESSURE PSI

# 5 285 PSI

# 1 OF 7 305 PSI

# 2 OF 7 ATTEMPT AT 305

# 3 OF 7 ATTEMPT AT 305

TIME - MSEC

system during this pressure pulsing. Only two pulses (#1 and #5) of the seven attempts at 305 psi actually read 300+ psi at the transducer placed at the far end of the pipe. Others read as low as 160 psi even though the pulsing system was set up the same way for all. I suspected the lower pressures were a sign of yielding, but no change was observed in the horizontal reading from 305 psi pulse #2 through #7. In any case, the tube withstood the pulses with little or no damage.

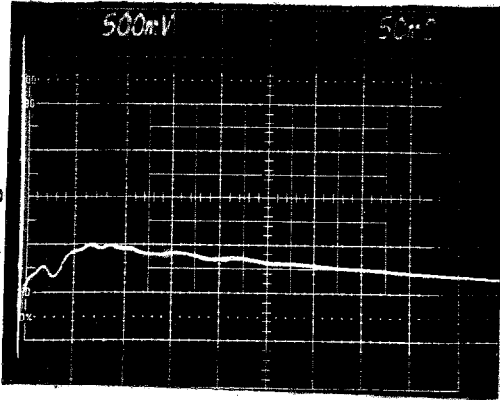
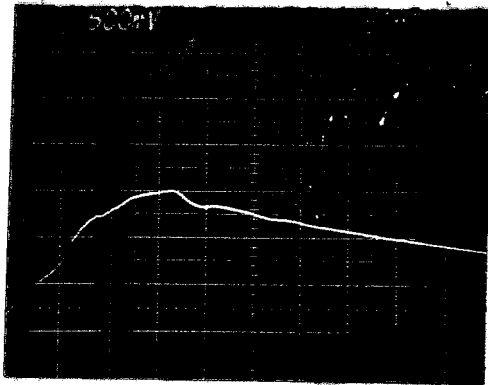
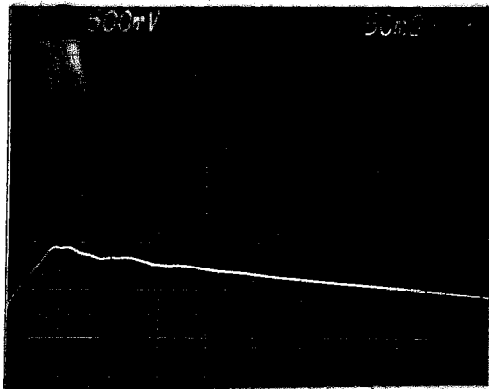
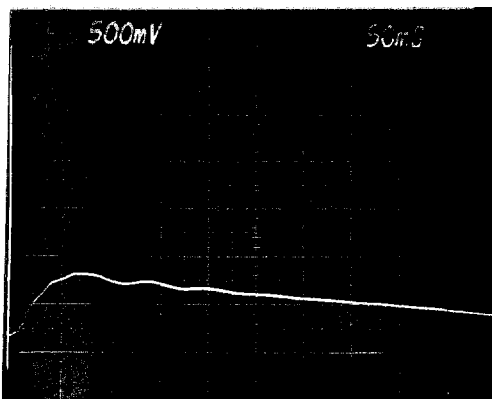
SHEET #3

PRESSURE PULSE RECORDS

PRESSURE PSI

#4 OF 7

ATTEMPT  
AT 305 PSI

#5 OF 7

#6 OF 7

#7 OF 7

ATTEMPT AT  
305 PSI

TIME M-SEC

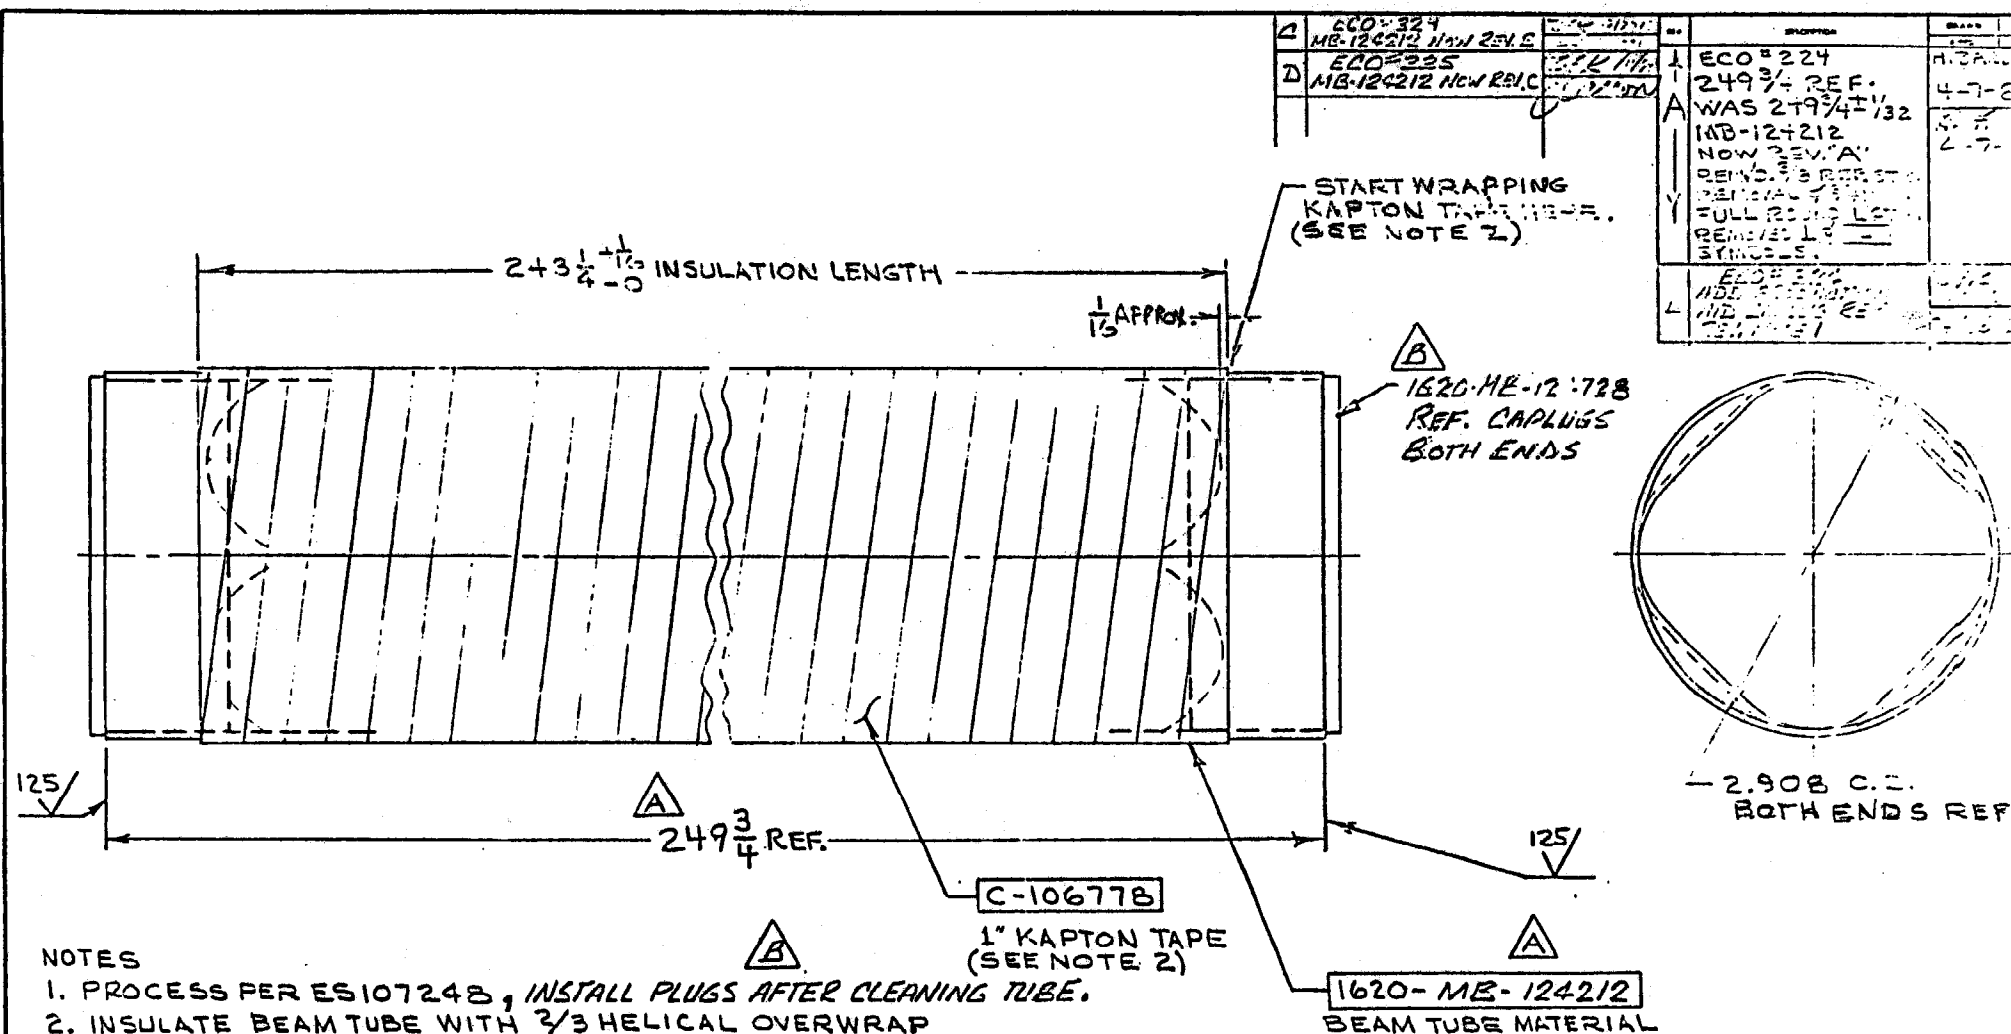
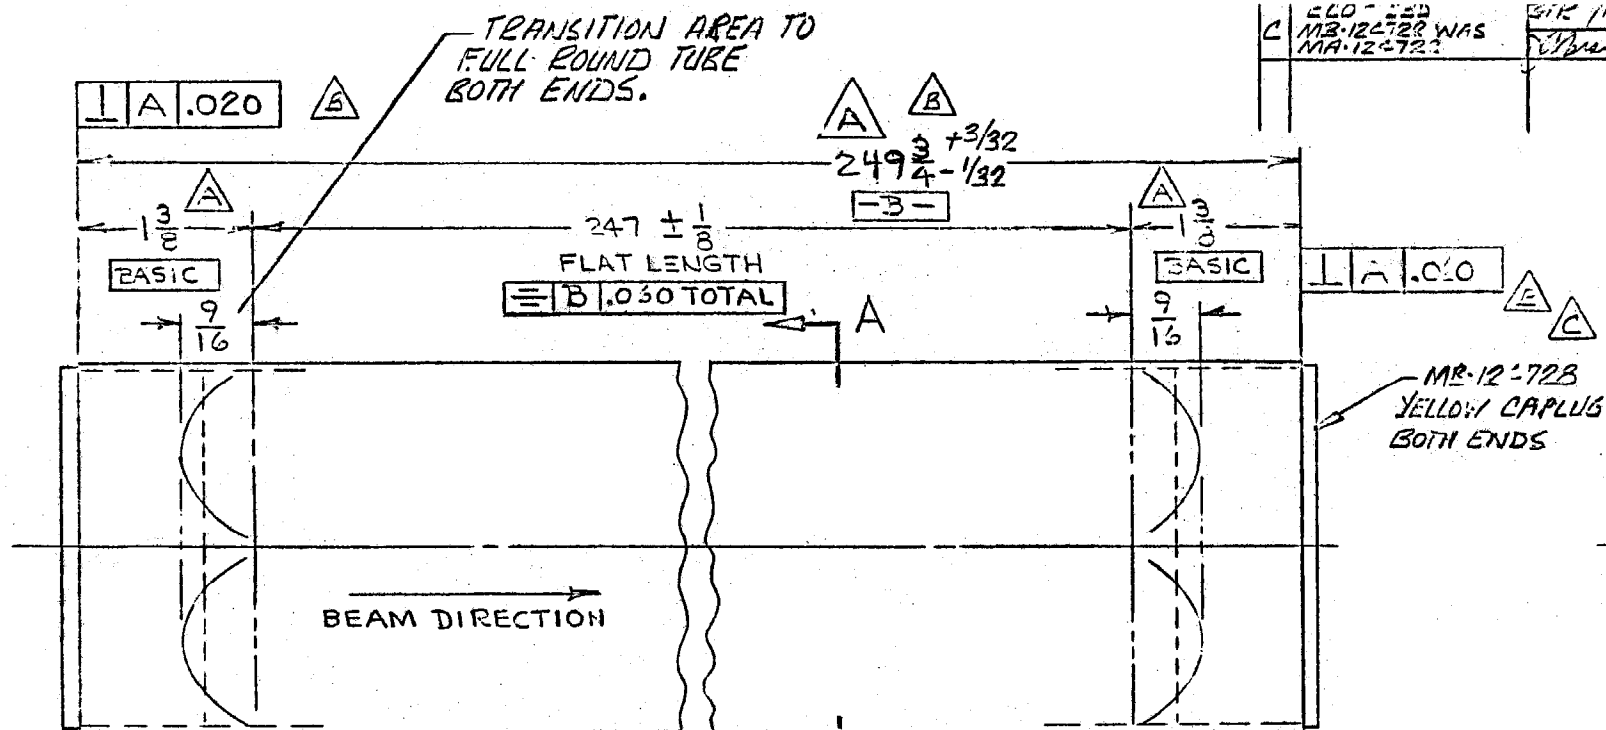
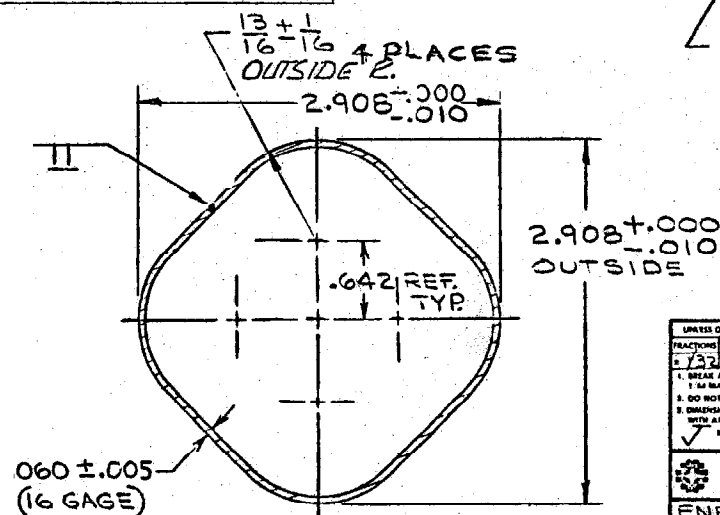
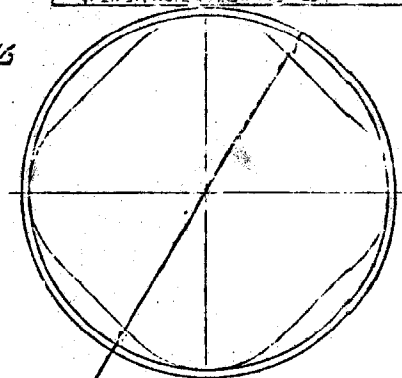
1. PROCESS PER ES10724B, INSTALL PLUGS AFTER CLEANING TUBE.
2. INSULATE BEAM TUBE WITH  $\frac{2}{3}$  HELICAL OVERWRAP OF KAPTON TAPE. IF A SPLICE IS REQUIRED OVERLAP FOR 1". TRIM BOTH ENDS SQUARE AS SHOWN. A TRIPLE LAYER OF TAPE SHALL EXIST AT EDGE OF TRIM CUTS.
3. CORNERS OF TUBE MAY BE LONGITUDINALLY TAPED WITH STRIPS OF KAPTON TAPE FOR INSERTION INTO COIL.

1. FABRICATE PER ES107228.
2. STRAIGHTNESS WITHIN  $\frac{1}{32}$ " FOR ANY 3 FT. AND WITHIN  $\frac{1}{4}$ " OVER THE TOTAL LENGTH.
3. TWIST NOT TO EXCEED  $1^\circ$  IN ANY 1 FT. AND  $5^\circ$  OVER TOTAL LENGTH.
4. WELD PER ES107230.
5. I.D. OF TUBE SHALL BE 2 D FINISH.
